CHAPTER TEN

BUILDING PRESERVATION, SPACE PROGRAMMING, & NEW FACILITY PHASING

Oakland has seven historic structures on the property that provide storage, house staff, and have interpretive qualities which all support Historic Oakland Foundation (HOF) and the city's collective vision for managing the cemetery.

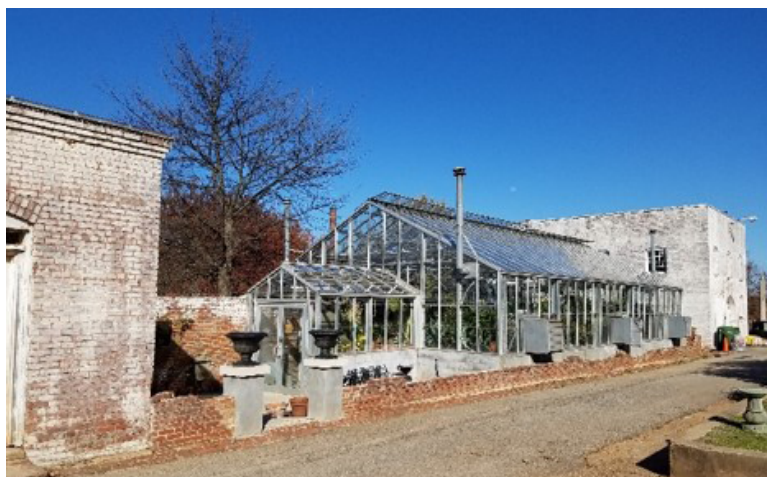
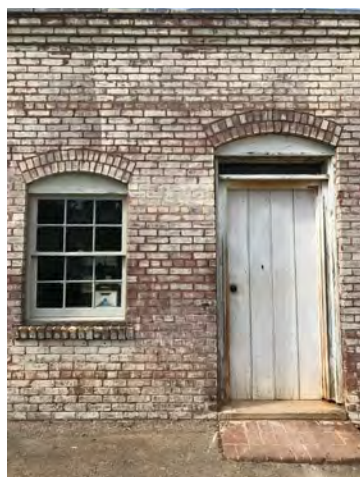
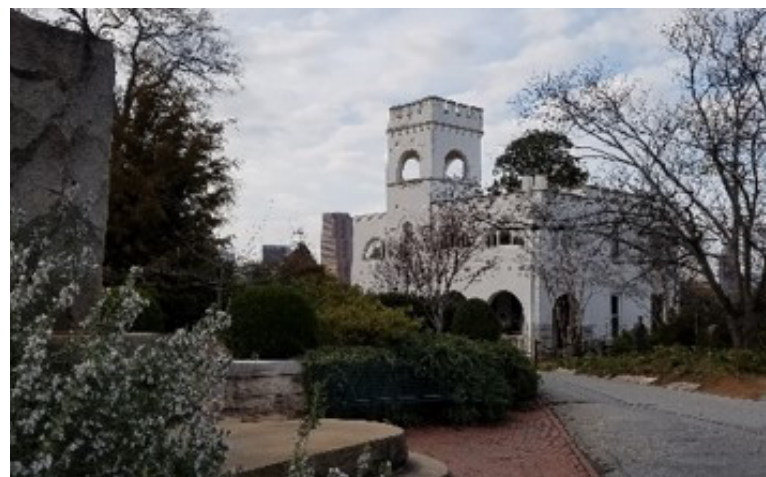
The new Greenhouse, Boiler Room, and Bell Tower.

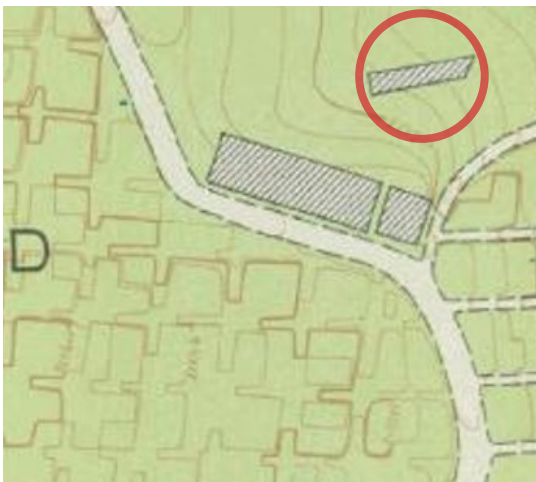
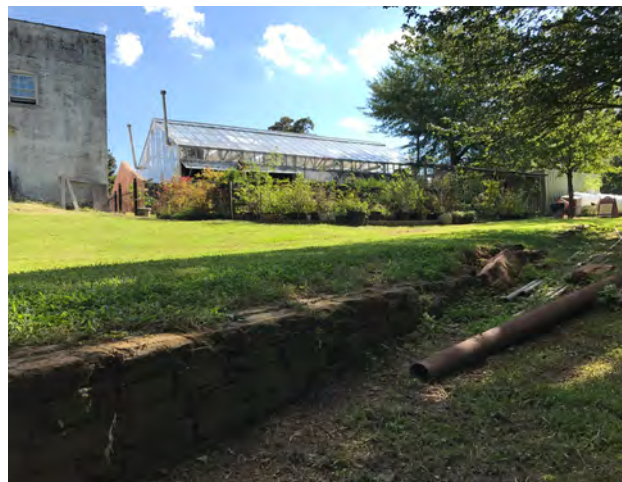
In 1915, a brick shed was built behind the Carriage House and Greenhouse. It was approximately 1,000 square feet and was used for storage. It has since been demolished, but a foundation remains.

- Concrete and brick foundation remains.
- Descriptions of the shed exist in historic documents.
- The building footprint appears in a 1930 topographic map of Atlanta (available through Emory University).
- The building profile appears in a historic aerial photograph from 1949 (available through GSU).

Left: The 1930 topographic map of Atlanta shows the location of the historic shed (circled in red). Right: the foundations of the shed north of the Greenhouse.

Reconstructing the shed building will help alleviate critical storage and staffing space needs for the cemetery. Equipment storage could be moved to the shed, or alternately, some HOF staff could be moved to the building. The former is the preferred option but is dependent upon the willingness of the city to relocate staff and equipment.

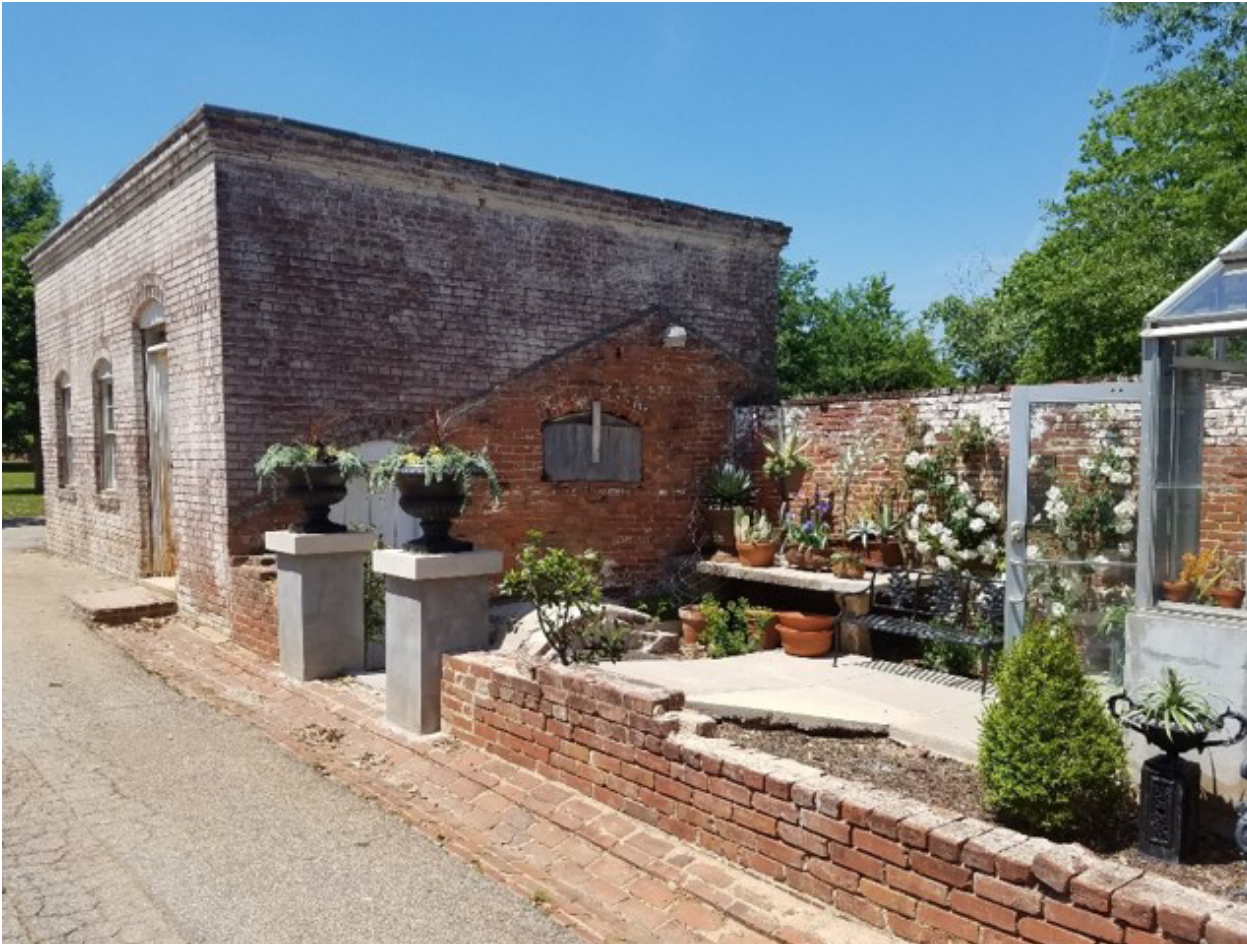
Boiler Room Overview

The Boiler Room was constructed in 1910 to support the function of the Greenhouse. It is a single story brick building with a flat roof. Its 480 square feet house the HOF's conservation studio and materials storage.

Current Condition: Fair

- The Boiler Room is structurally sound.
- There is no gutter at the rear of the flat roof.
- Brick on the rear of the building is in poor condition due to water runoff from roof.
- There are new electrical and HVAC systems
- There is improper water runoff at the north wall that is causing soil erosion.
- Restoration staff operate out of this building.

The Boiler Room is in overall fair condition but requires some maintenance. The primary use of the Boiler Room as the center of restoration activities should remain. Following needed minor repairs, construction of a viewing area for visitors to observe conservation practices should be considered. The benefits of this area would be to educate visitors about Oakland’s preservation and restoration mission.

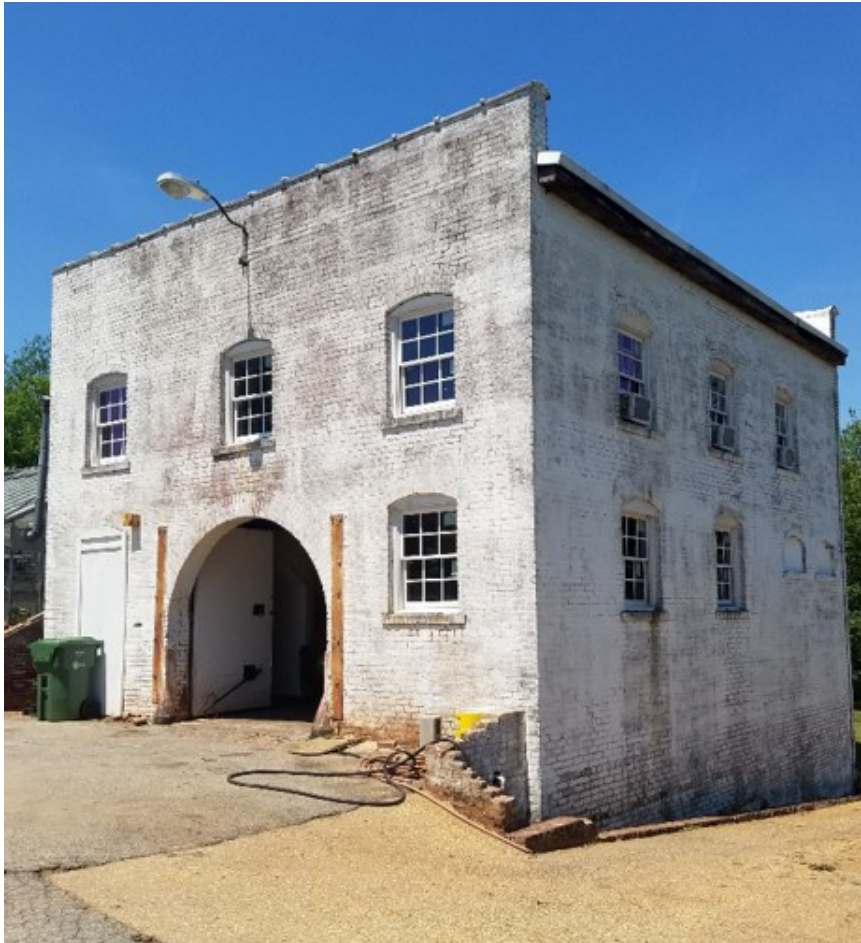
Carriage House Overview

The Carriage House was constructed in 1908 as a barn. It is a two story brick masonry structure and currently houses city equipment and staff. At 2,100 square feet, it is the second largest building on site. It has the best access for those with disabilities due to the at-grade front door.

Current Condition: Fair

- The Carriage House is structurally sound.
- The brick is in fair condition.
- There are new windows.
- The Carriage House has drainage problems at the east wall.

The Carriage House is one of the largest buildings on site, yet has relatively light usage. As shown in the phasing plan, the building can have expanded capacity to include relocation of some HOF staff, reference materials, public ADA restrooms, and meeting space.

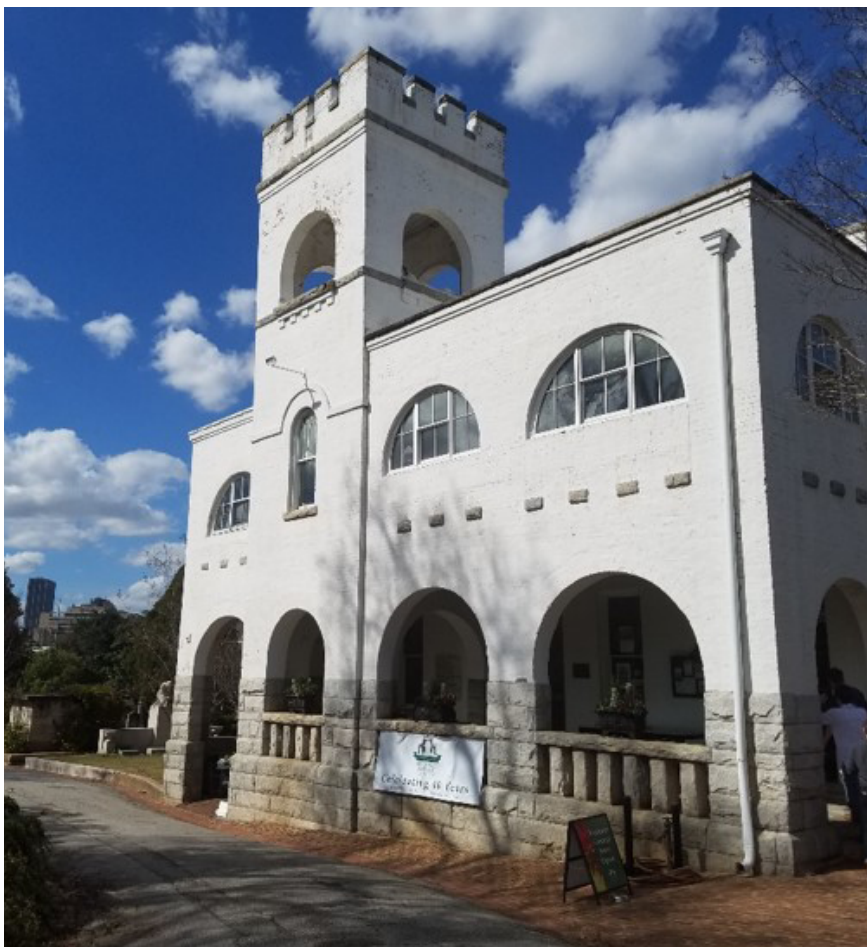
Bell Tower Overview

The Bell Tower was constructed in 1899 as the sexton's office and public restrooms. It is an ornate 2,800 square foot building that now houses the sexton's office, HOF offices, public restrooms, meeting space, archives, gift shop, snack bar, and storage.

Current Condition: Fair

- The building is structurally sound.
- The roof has significant leakage, especially at the northwest corner.
- Electrical upgrades are needed.
- Plumbing upgrades are needed.
- Brick repointing is needed, especially at the west wall.
- ADA compliance is recommended.

The Bell Tower is overused and ready for another round of maintenance. Full rehabilitation is recommended and roof replacement is a high priority. Relocation of activities out of the building is also recommended, which is dependent on a new Visitors Center facility outside of the gates. As the largest and most ornate historic building on site, it should be considered for

1. CRITICAL- coordinate with the city for Roof evaluation and repair. Address masonry failure and window leaks.
2. Discuss relocation of some HOF staff to Carriage House with city – would require relocation of city staff out of Carriage House.
3. Explore feasibility of use as events rental or café.
4. Develop construction documents.
5. Solicit three bids from licensed contractors experienced in historic rehabilitation. Design and permit construction documents – would require AUDC review.
6. Perform rehabilitation.

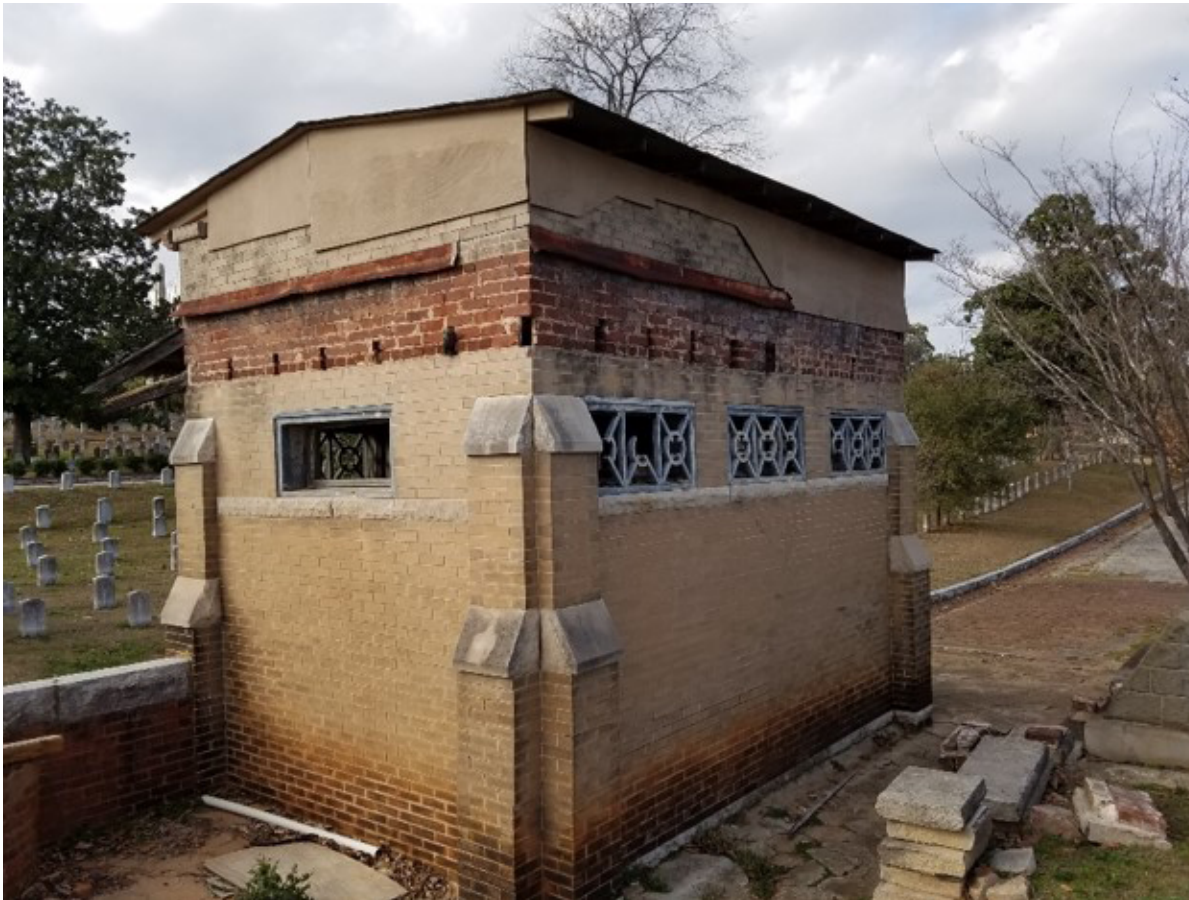
Women's Comfort Station Overview

The Women's Comfort Station was constructed in 1908 for use as a women's restroom. It is a 160 square foot single room building. It has been vacant for years and has fallen into disrepair. Additionally, it was severely damaged by a tornado in 2008.

Current Condition: Critical

- There is structural cracking and separation of brick at southeast and northwest corners.
- There is a deteriorated gable roof installed over flat roof.
- Wood lintels are rotten and failing, leading to brick masonry damage.
- The bent roof made of pressed tin and woodwork were removed and lying on the ground.
- The decorative transom screens are damaged.
- Interior plaster and tile are damaged.

1. CRITICAL: stabilize masonry and roof with help of an individual with woodworking experience.

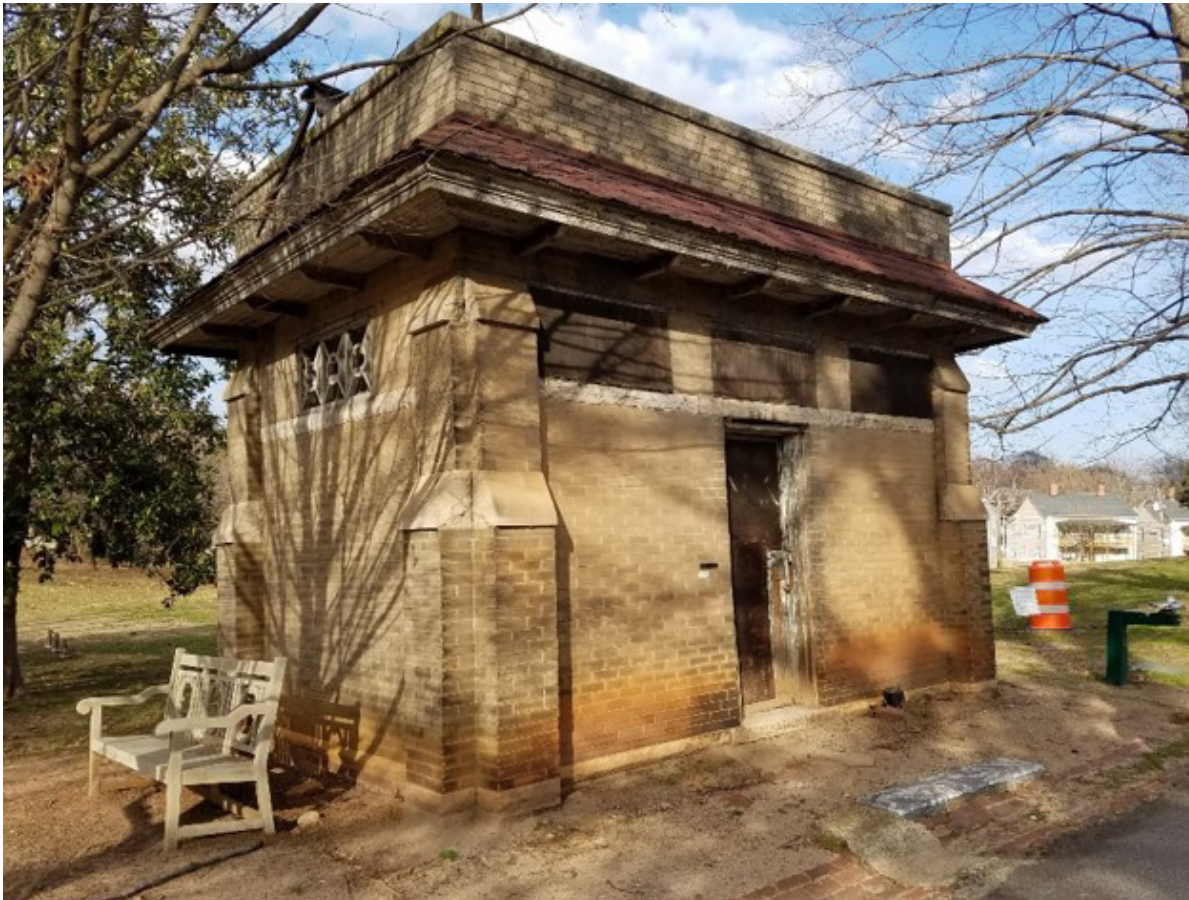
Men's Comfort Station Overview

The Men's Comfort Station was constructed in 1908 for use as a men's restroom. It is 200 square feet and has a separate storage room. It has been vacant for years and has fallen into disrepair.

Current Condition: Poor

- There is noticeable settling and it is unknown if this is old or continuing.
- There is a door that has fallen off its hinges.
- The bent roof is made of pressed tin, and the woodwork is in disrepair.
- The decorative transom screens are in disrepair.

1. Evaluate and monitor settling for 1 year. If it continues, seek an unbiased opinion from a professional engineer to guide a plan for reinforcing the foundation.
2. Develop an appropriate use for the building.
3. Develop construction documents.
4. Solicit three bids from licensed contractors experienced in historic rehabilitation.
5. Perform rehabilitation.

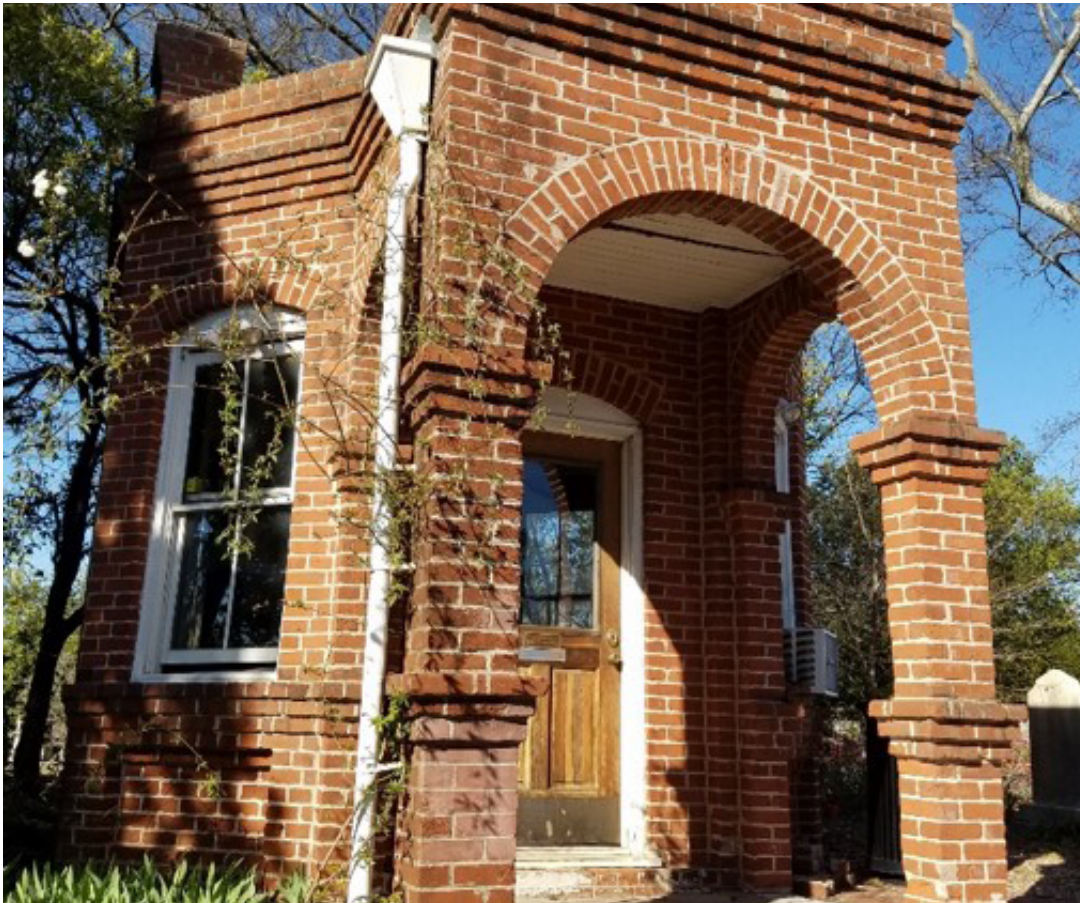
Guardhouse Overview

The Guardhouse was constructed in 1908 as a watch house and continues in limited capacity in that function today. It is an approximately 100 square foot single room brick building. Its distinguishing features are a hexagonal floor plan and a prominent arched entry portico. The Guardhouse was last restored in 1978.

Current Condition: Fair

- The building requires a new roof.
- The brick steps are damaged.
- The plaster ceiling is damaged.
- The old window a/c unit should be relocated to rear.
- There is one broken window.
- There is inappropriate brick replacement and repointing in areas.

The Guardhouse is in fair condition. Its last rehabilitation was in 1978, making it due for another round of maintenance. It's visibility near the west entrance and addition of security staff in the near future also require it be functional and up-to-date.

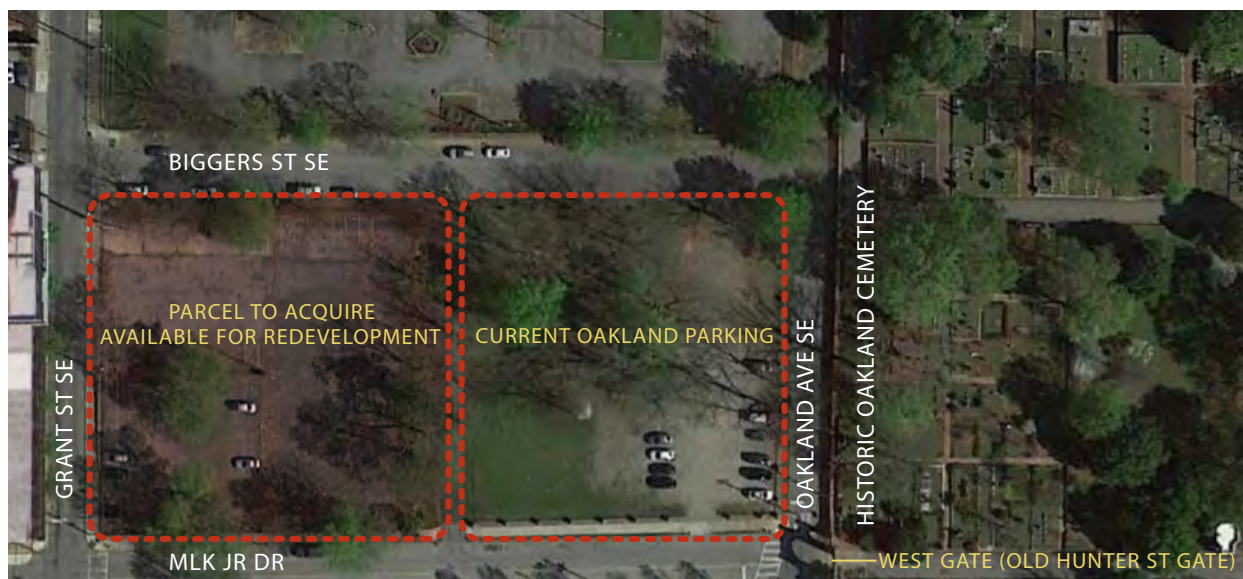
Construction of the new Visitors Center outside of the Old Hunter St. Gate is contingent on the acquisition of the parcel above and left. Oakland currently owns the parcel nearest to the cemetery.
